Fifeville Neighborhood Revitalization Initiative

307 5th St. SW

before

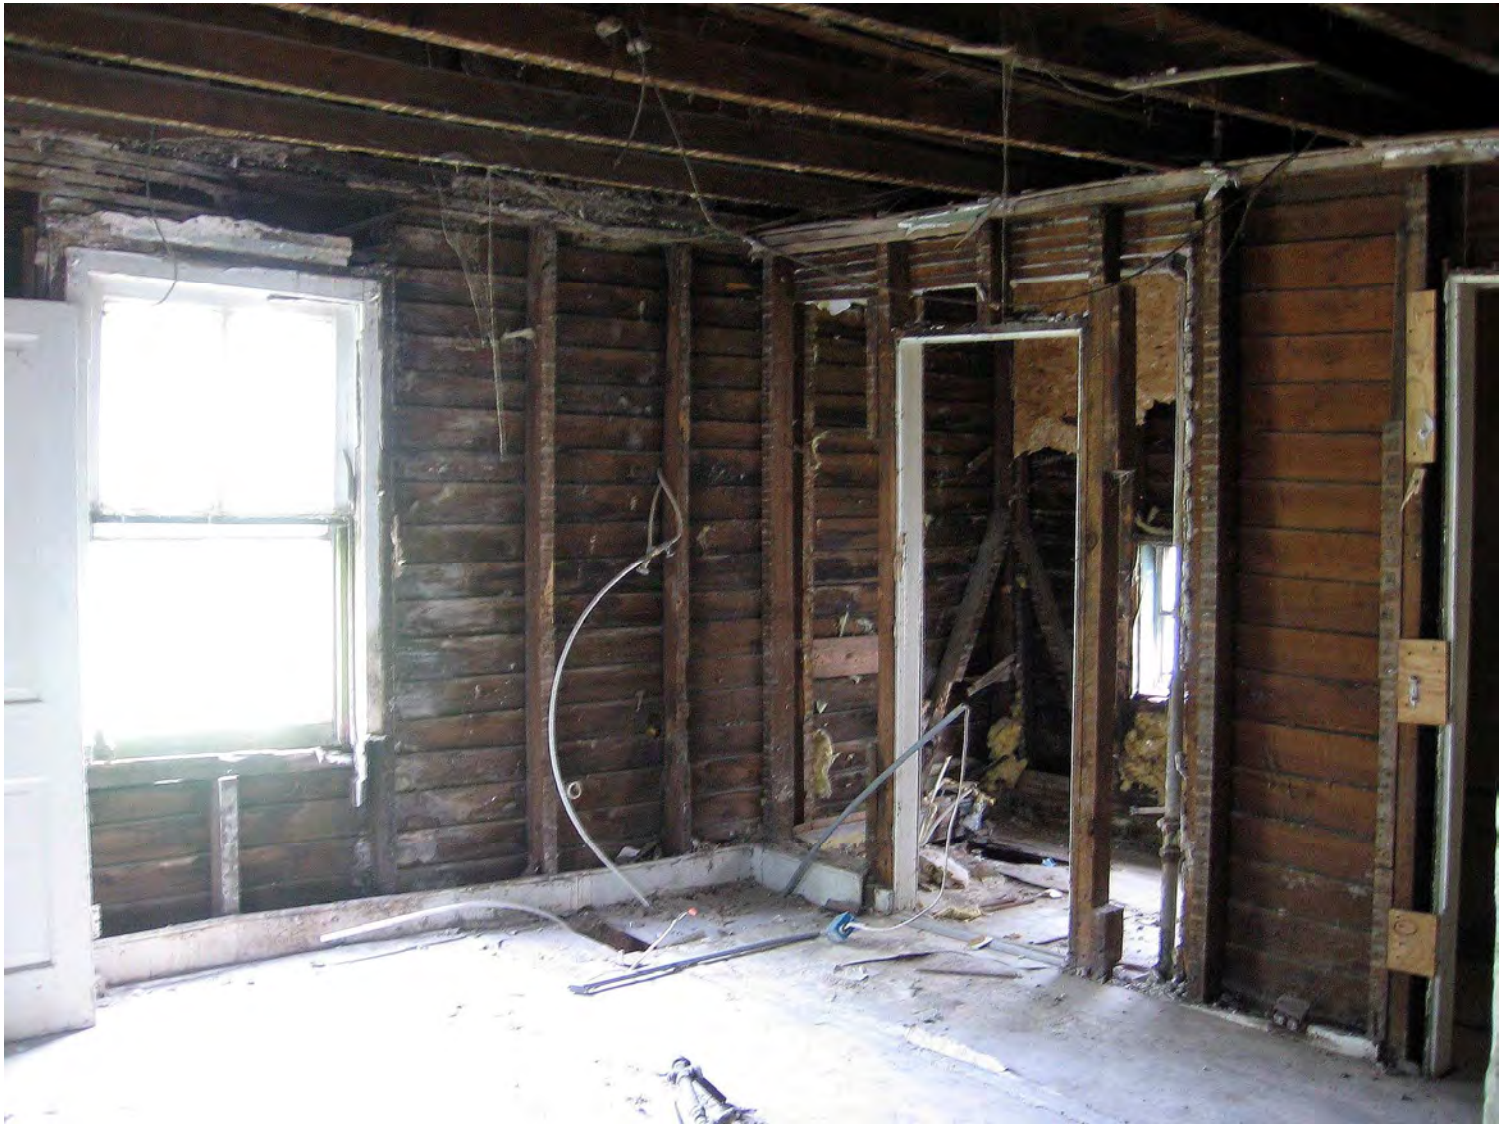
second floor, rehab work begun

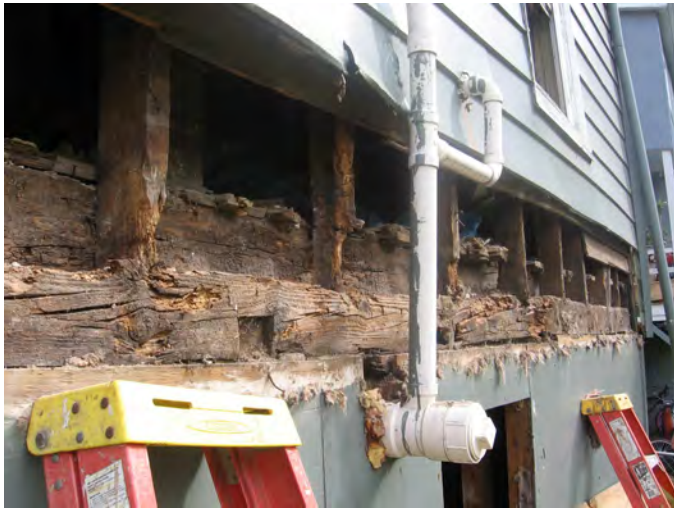
water damage, west wall

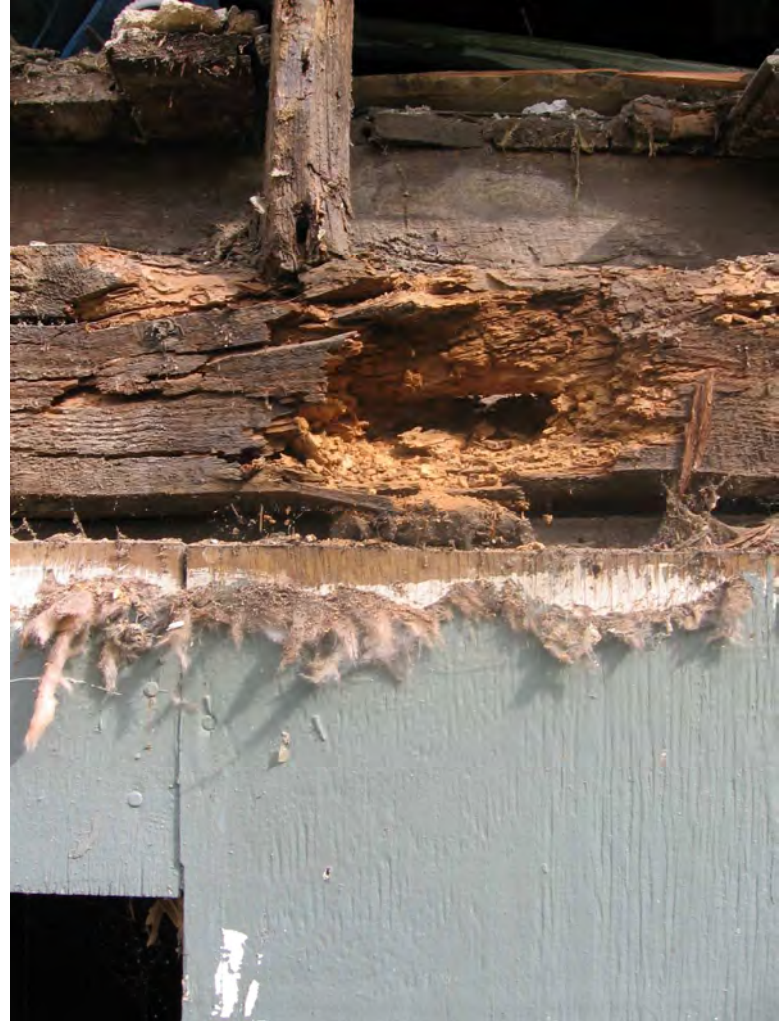
water-damaged stud and beam, detail

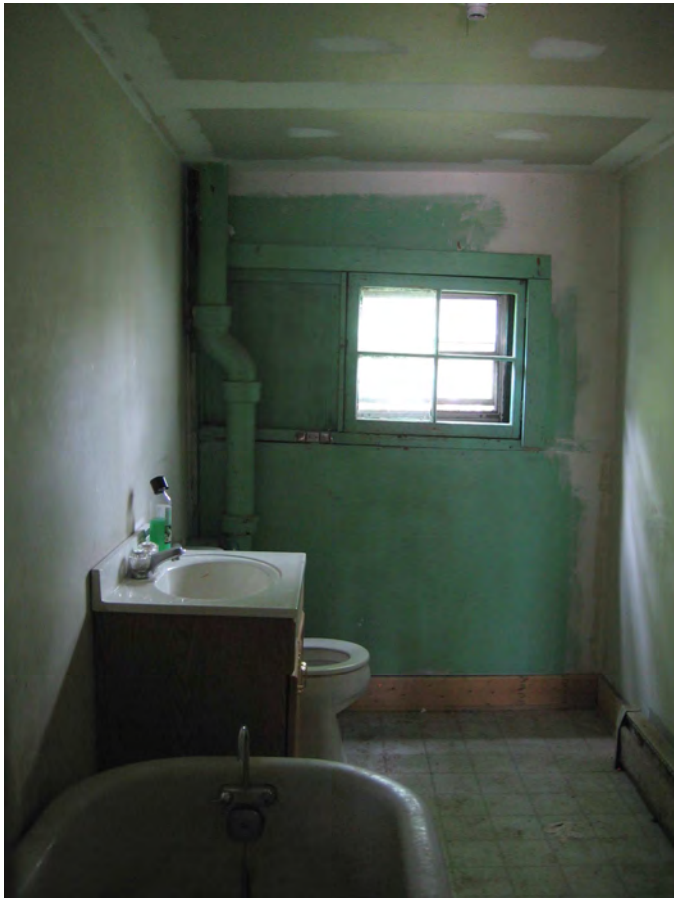
bathroom, first floor

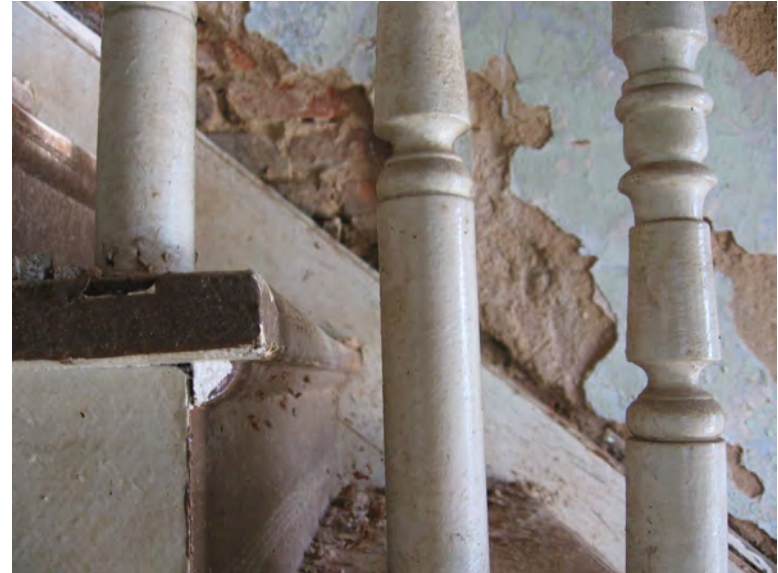
stair and interior wall

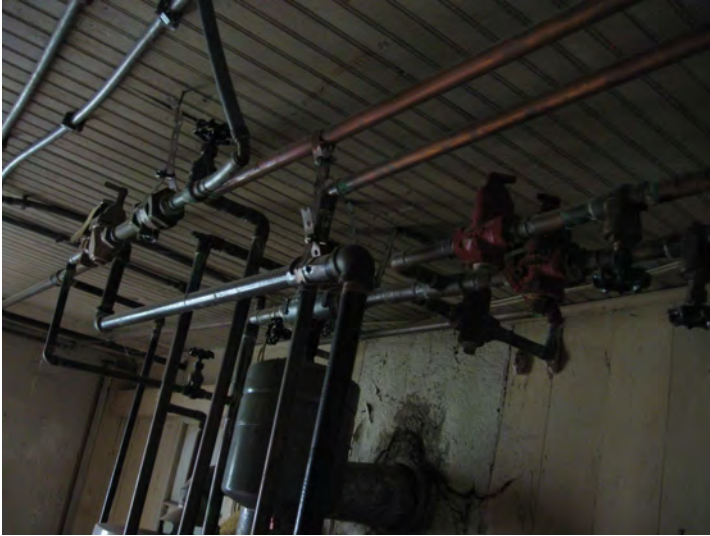
plumbing, basement

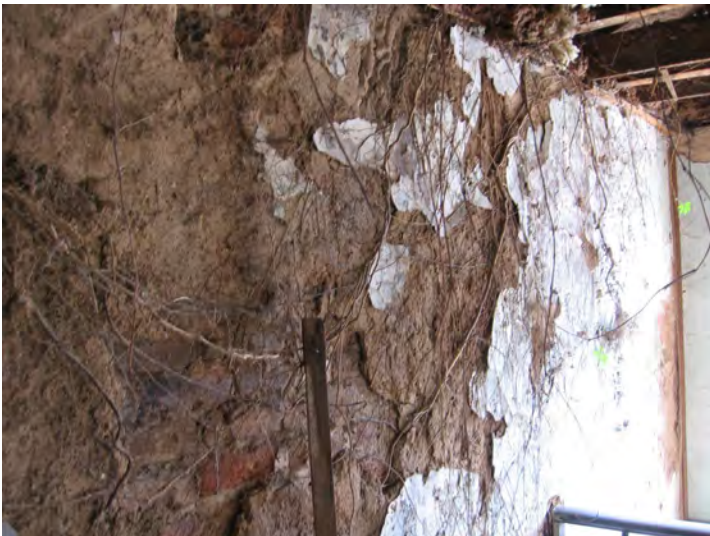
interior wall, second floor

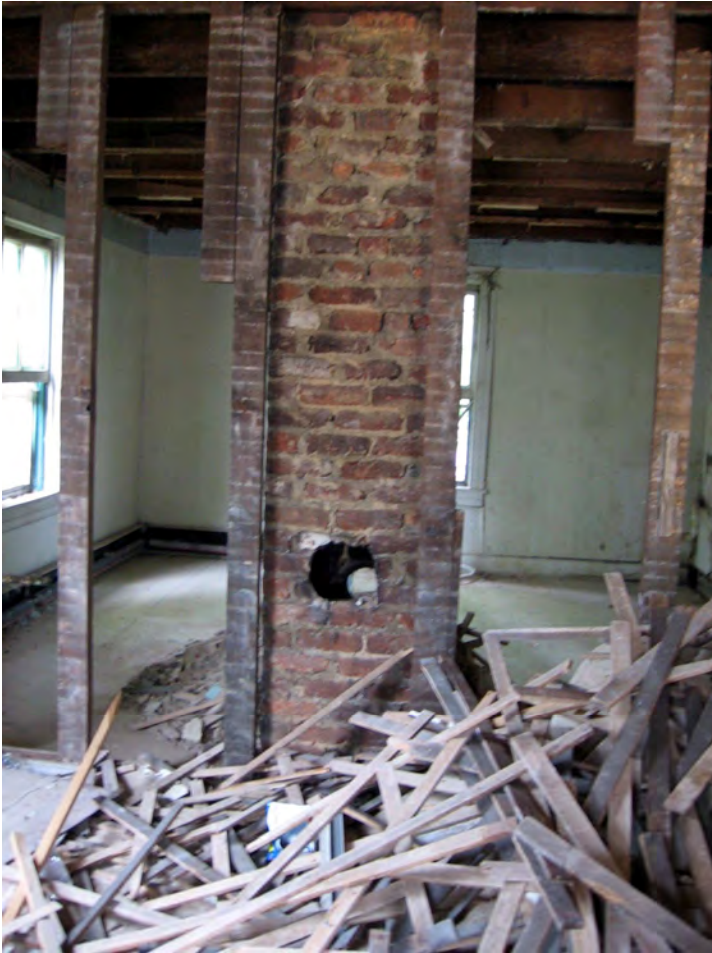
second floor, rehab work begun

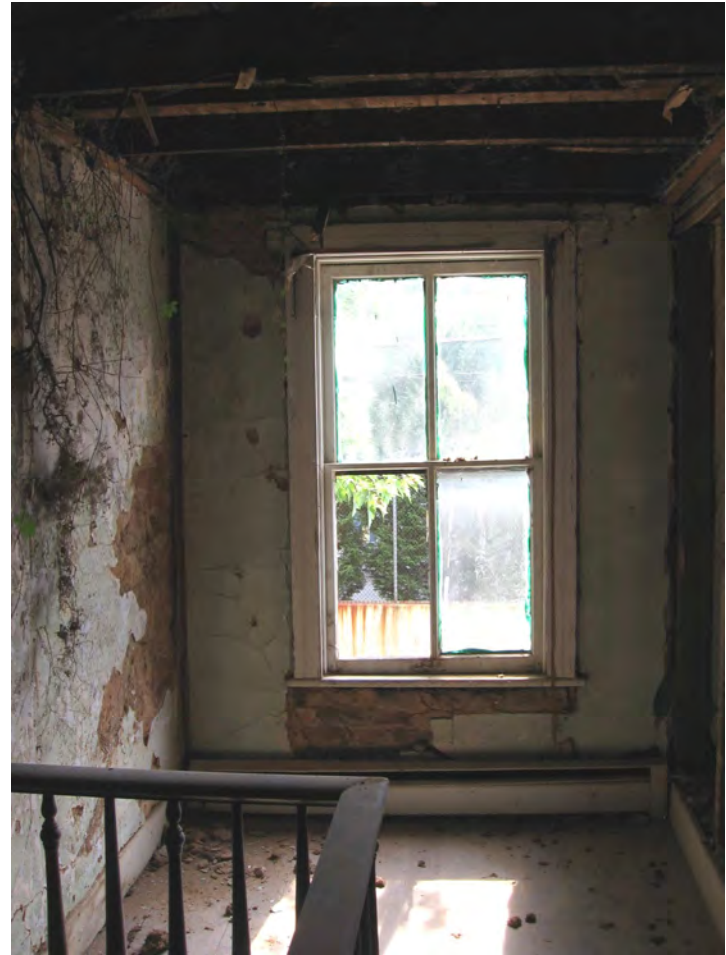
window, second floor
